DRAFT Preliminary Evaluation

To: College Place Lions Club
By: John Wells, PE, Anderson Perry & Associates, Inc.
RE: Fishing Pond Improvements
Date: January 13, 2015

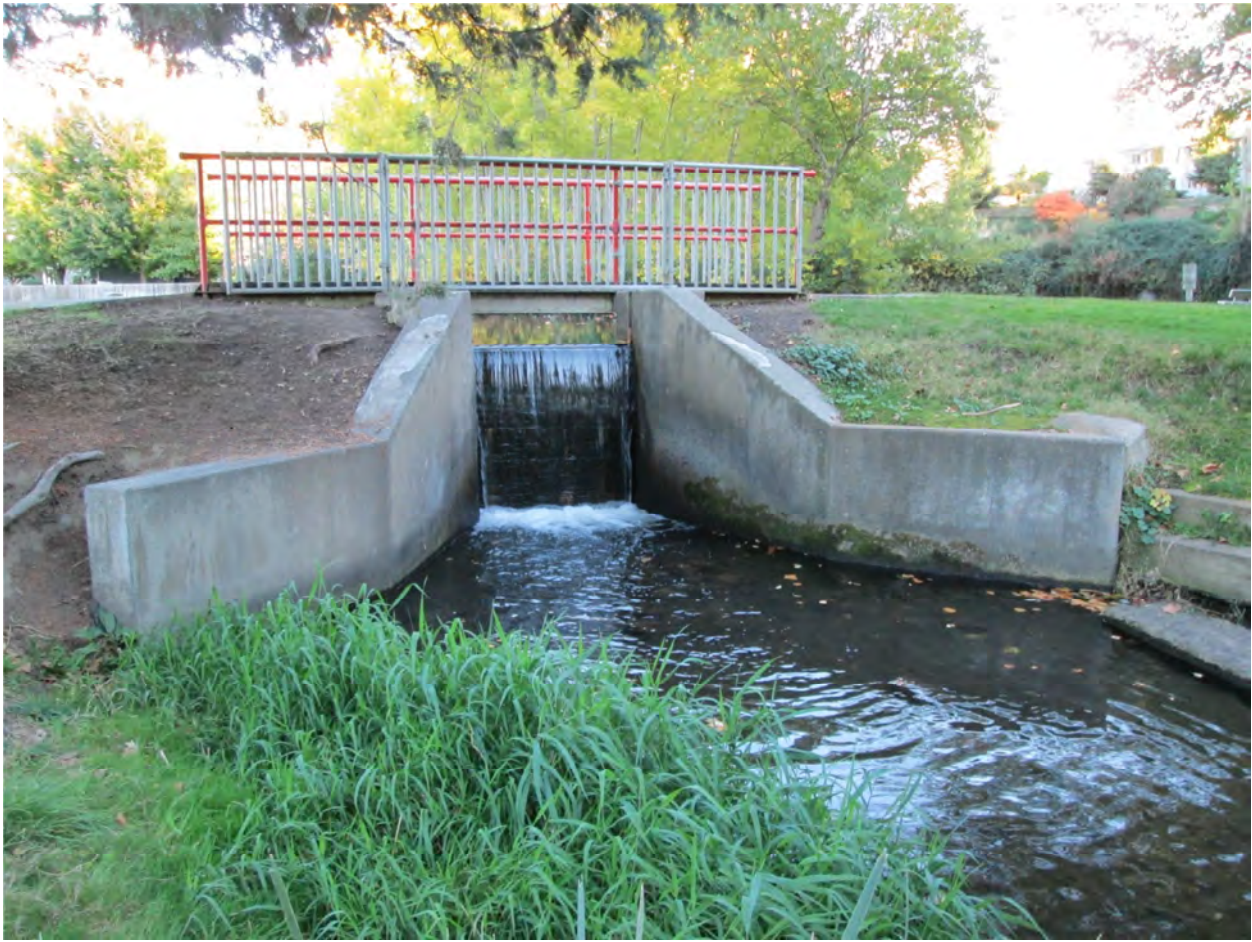
Photo 1. Fishing Pond Outlet

The current pond system is hydraulically connected to Garrison Creek as it flows across the south corner of the park from east to west. The pond is located in the southeast corner of the park with the pond inlet along the far eastern property boundary and the outlet located at the pond termination point where the creek returns to surface stream channel. There is currently no inlet diversion to direct water out of Garrison Creek since the entire creek flows through the pond. The existing pond outlet check structure at the downstream end of the pond allows water to exit the pond by spilling over a weir. The outlet check structure is approximately 5 feet tall with wooden check boards installed to create the impoundment as shown in Photo 1.

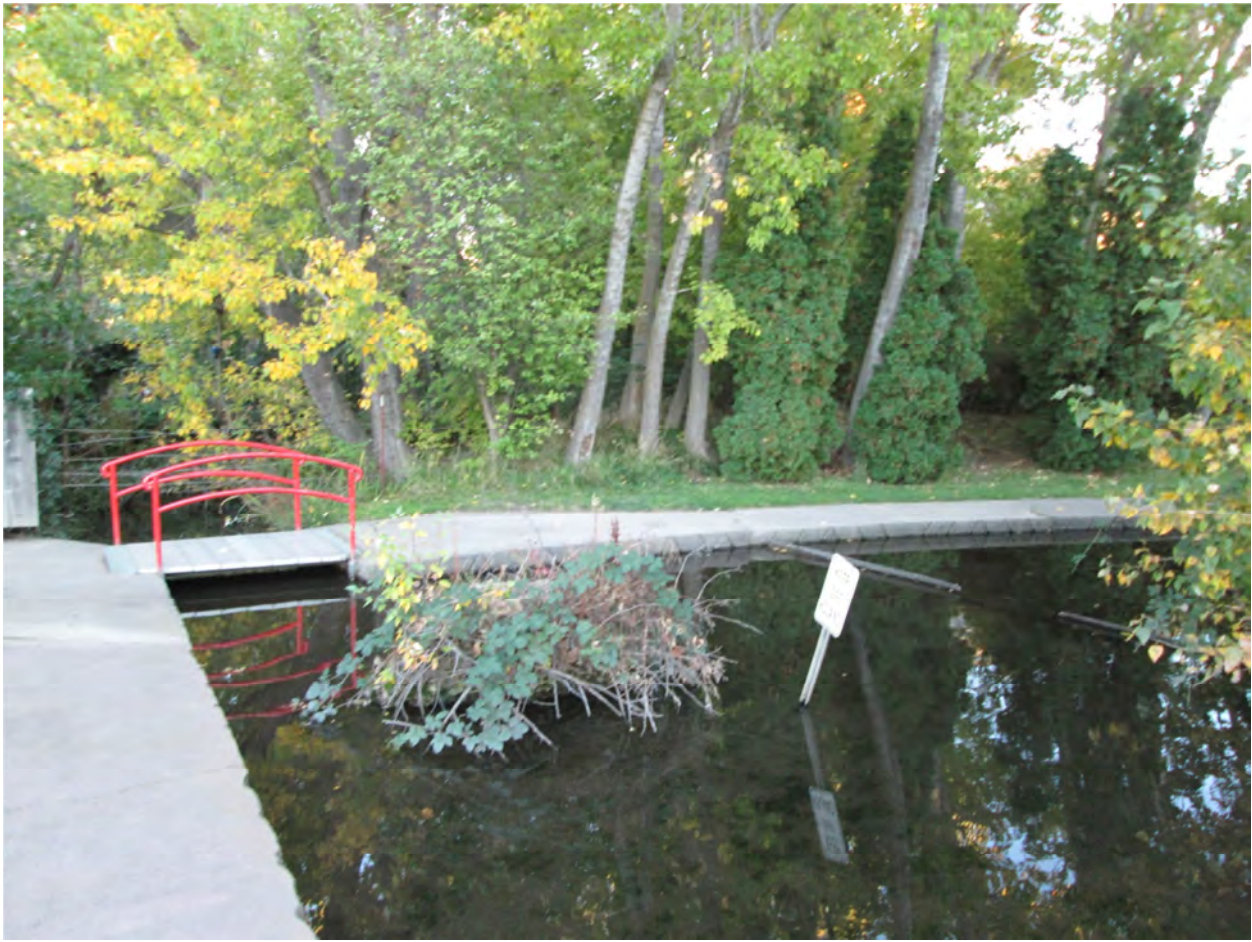
Photo 2. Pond Inlet showing the vertical drop off at the waters edge

The pond is approximately 240 feet in length from east to west and approximately 180 feet in length from north to south, but is oblong shaped with an area of approximately 0.54 acres. The pond has concrete sidewalk around the edge of the pond, some of which is sloping toward the water's edge with a vertical drop off at the water's edge.

As previously noted, the existing pond has several issues, one of which is the sloping concrete sidewalk which tends to slope toward the water's edge in many places. Throughout many times of the year the concrete perimeter walkway is wet and slippery. The walkway is a public safety hazard to young children and the disabled who could inadvertently slip and fall into the water. In addition, wheel chairs being driven on the walkway could lose traction and end up sliding off the edge into the water. Both of these scenarios could potentially lead to loss of life.

Option A – Remove and replace extreme sloping perimeter concrete pathway segments and install hand rail around the entire pond. The handrail would likely need to be 30 inches tall with two 1-1/4 inch steel pipe hand rails and kick plate at the bottom. The handrail system would be either galvanized or epoxy coated for longevity. The handrail would be anchored to the existing concrete except for some removable hand rail segments to facilitate future pond cleaning. The hand rail at the edge of the pond would reduce public safety risk for accidents for small children and handicapped individuals. The handrail would need to run continuously around the pond.

Option B – Remove the entire concrete perimeter sidewalk around the pond and replace with a berm and an earthen graveled walking path. The concrete walkway is 4 feet wide and is estimated to be 4-inches thick. Based on the perimeter length of 680 feet there would be 50 tons of concrete to removed and disposed from the site. To create a berm around the pond would require 550 cubic yards assuming a berm 1.5 feet tall, 10 feet wide 3H:1 vertical sloping sides and a top width of 5 feet. Landscape features would likely be desired to reduce soil erosion. Also gravel would be required to a minimum depth of 4-inches on the walkway area would require 42 cubic yards of gravel.

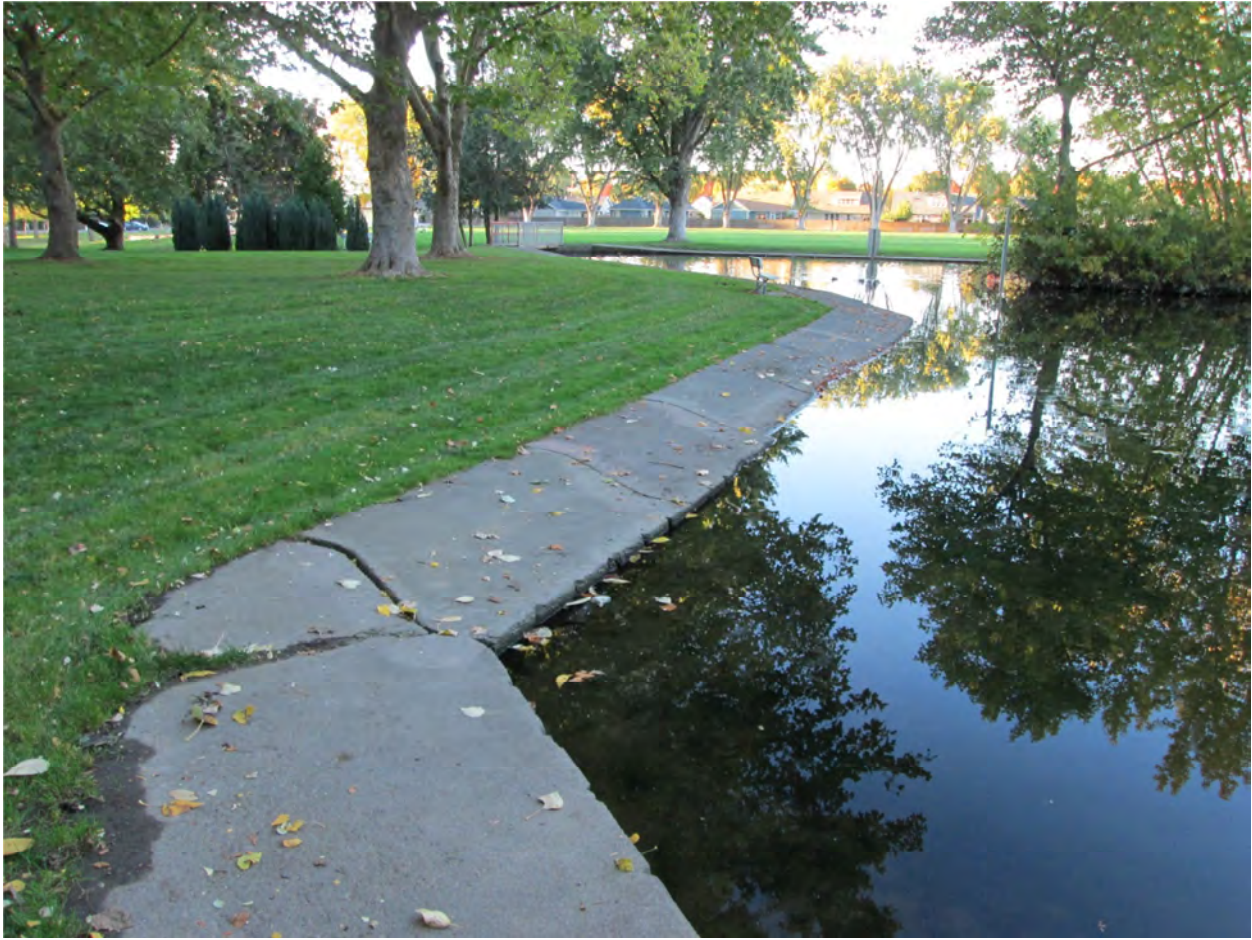
Photo 3 - Sloping concrete pathway at the water's edge of the pond

The pond appears to be approximately 18 inches deep immediately off of the concrete sidewalk and appears to deepen to between 4 to 6 feet at its deepest point in the middle of the pond. Some of the concrete sidewalk has cracks and is showing signs of deterioration, especially at the ponds edges where the concrete is sloping most toward the water surface(Photo 3).

The advantage of having a concrete surface around the pond is that it provides additional opportunity for handicapped individuals to access the pond. Sloping concrete that needs to be removed and replaced is estimated to be approximately 100 feet in length or 45 square yards of concrete. The abrupt edge of the pond at the water's edge can only be mitigated by removing additional concrete or installing a hand rail around the pond.

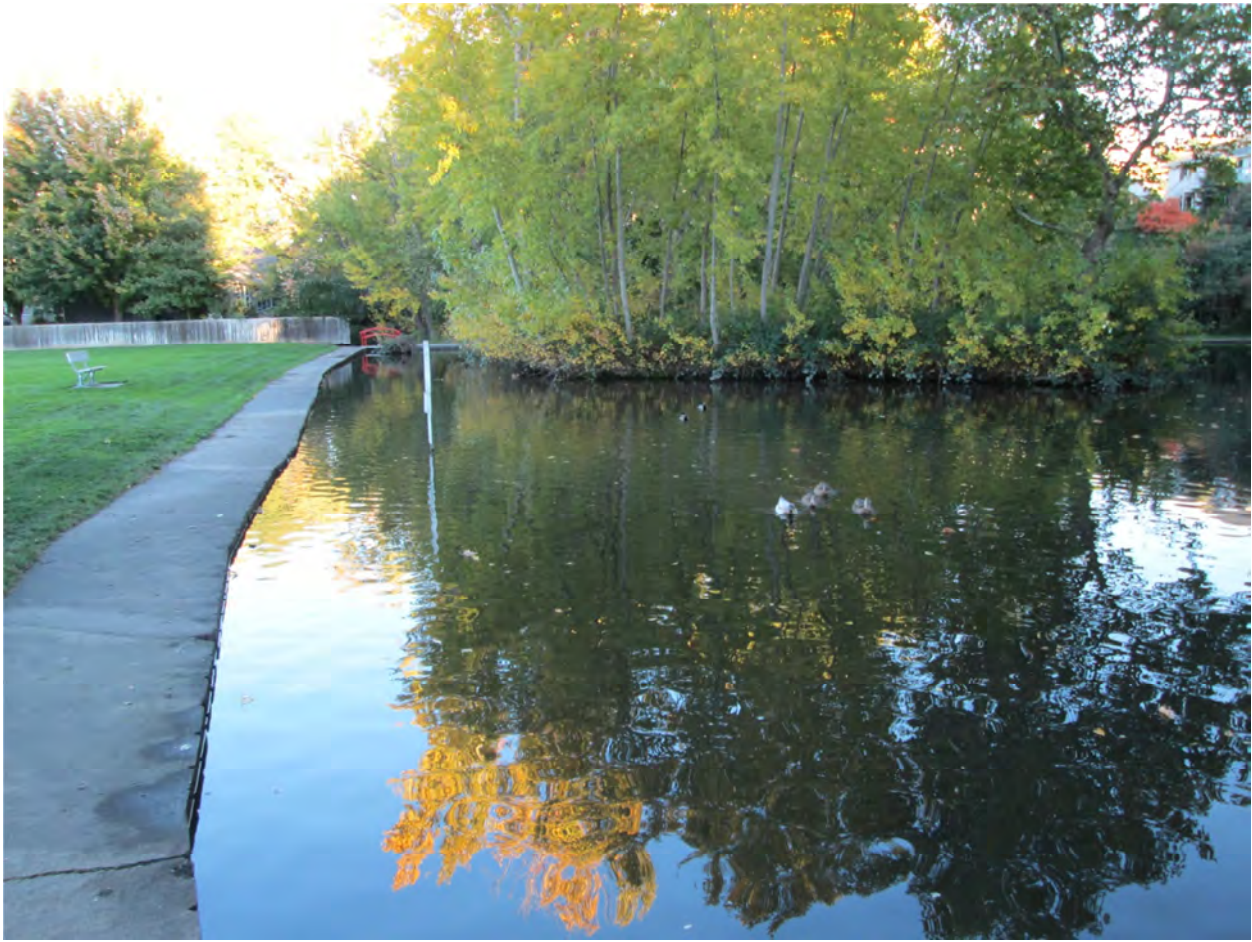
Photo 4 – Tree covered island. Facing from near existing pond outlet toward the east and the new proposed inlet.

The pond has an interior island that is covered with trees, briars, and bushes (Photo 4). The stormwater pipe enters at the southwest corner of the pond. This stormwater pipe collects stormwater from along Southeast 12th Avenue until reaching Dalles Military Road as shown on Figure 1. The stormwater pipe is shown in photo 5 as the concrete manhole against the hillside covered in vegetation.

Reduction of sediment to the fishing pond from Garrison Creek would require a new inlet and outlet of the fishing pond. The island would be eliminated tied in and connected to the existing land and would be turned in to a land bridge(Figure 3). The fishing pond size would be reduced by about half, but this is not expected to be an issue since the remaining area is the most used by anglers. The north side of the pond would be turned into a stream. The outlet structure of the existing pond would be removed and the stream would be sloped toward the east at approximately a 2 percent slope, forming one continuous riffle from the current pond outlet structure upstream to the new pond inlet structure as shown on Figure 2. The new stream channel formed would be approximately 260 feet long, 2 percent slope, 10 feet wide at the bottom. It would be about 5 feet deep when matching into the existing channel bottom near the current pond outlet structure as shown on Figure 3. The stream section would be filled with stream bed simulation material, (boulders and gravels) to form a roughened channel. These improvements would remove the island from the fishing pond and the new north bank would now be covered in trees, and there would likely be a small walking path developed through this tree area to allow full access around the pond. The pond would be taken out of the main sediment channel by installing a new diversion structure at the far western point of the property. This diversion structure would need to take water off of the middle of the Garrison Creek water column, letting sediment and debris primarily by-pass the pond and would need to have a fish screen to keep fish in the stream and prevent leaves and other deposits from entering the pond at the surface. This diversion would be a new diversion structure. Since the fishing pond is being enclosed, the outlet would be an overflow outlet, along with a drain outlet.

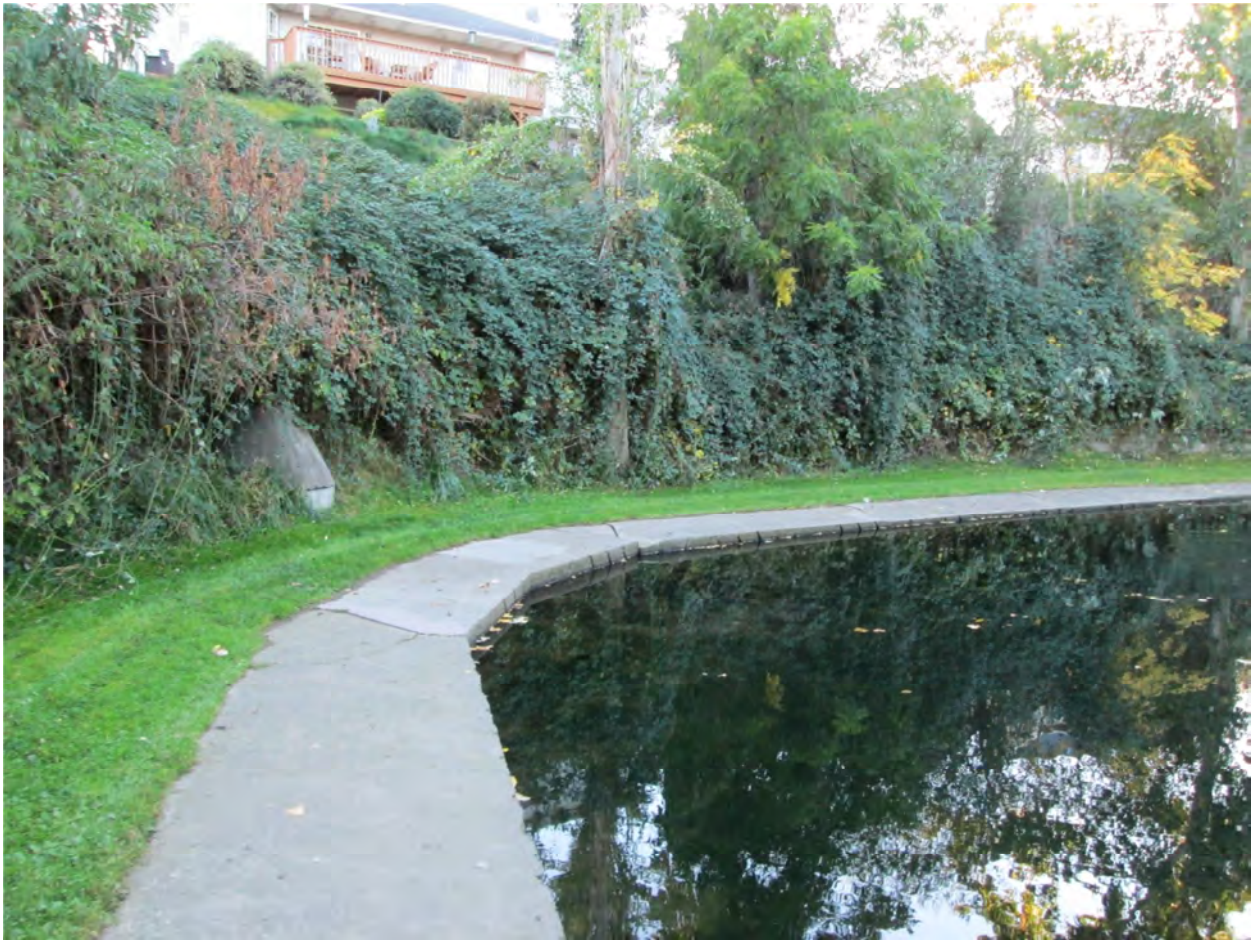
Photo 5. Stormwater inlet pipe to the fishing pond.

A second problem is that stormwater enters this pond directly from Southeast 12th Avenue and does not receive any treatment prior to being discharged directly into surface water which then flows to the confluence with the Walla Walla River. Sediment and pollutants from nearby roadways are potentially carried by stormwater and deposited in the pond and then downstream.

The stormwater pipe that discharges directly into the pond should be routed to a stormwater treatment area such as a grass lined swale as shown in Figure 2. The stormwater pipe comes down a steep hill before entering the fishing pond. This pipe could be intercepted and routed along the hillside at approximately a 1 percent slope until exiting to the west side of the pond into the open area that would be converted into a grass lined swale. The swale could be run through the open park area toward the west. The swale would be dry during the majority of the summer season and only carry water during the rainy season. The grass-lined swale would be a stormwater treatment feature which would improve stormwater quality and would also capture some of the sediment and pollutants. Depending on City and County requirements, the stormwater feature could also function for some storage prior to discharging into the creek approximately 100-200 feet downstream of the existing pond structure. This stormwater swale would be an improvement to the City stormwater and would result in some benefit of reducing sediment and potential pollution of oils and grease discharged to Garrison Creek. The added benefit would also be to reduce sediment deposition directly into the fishing pond.

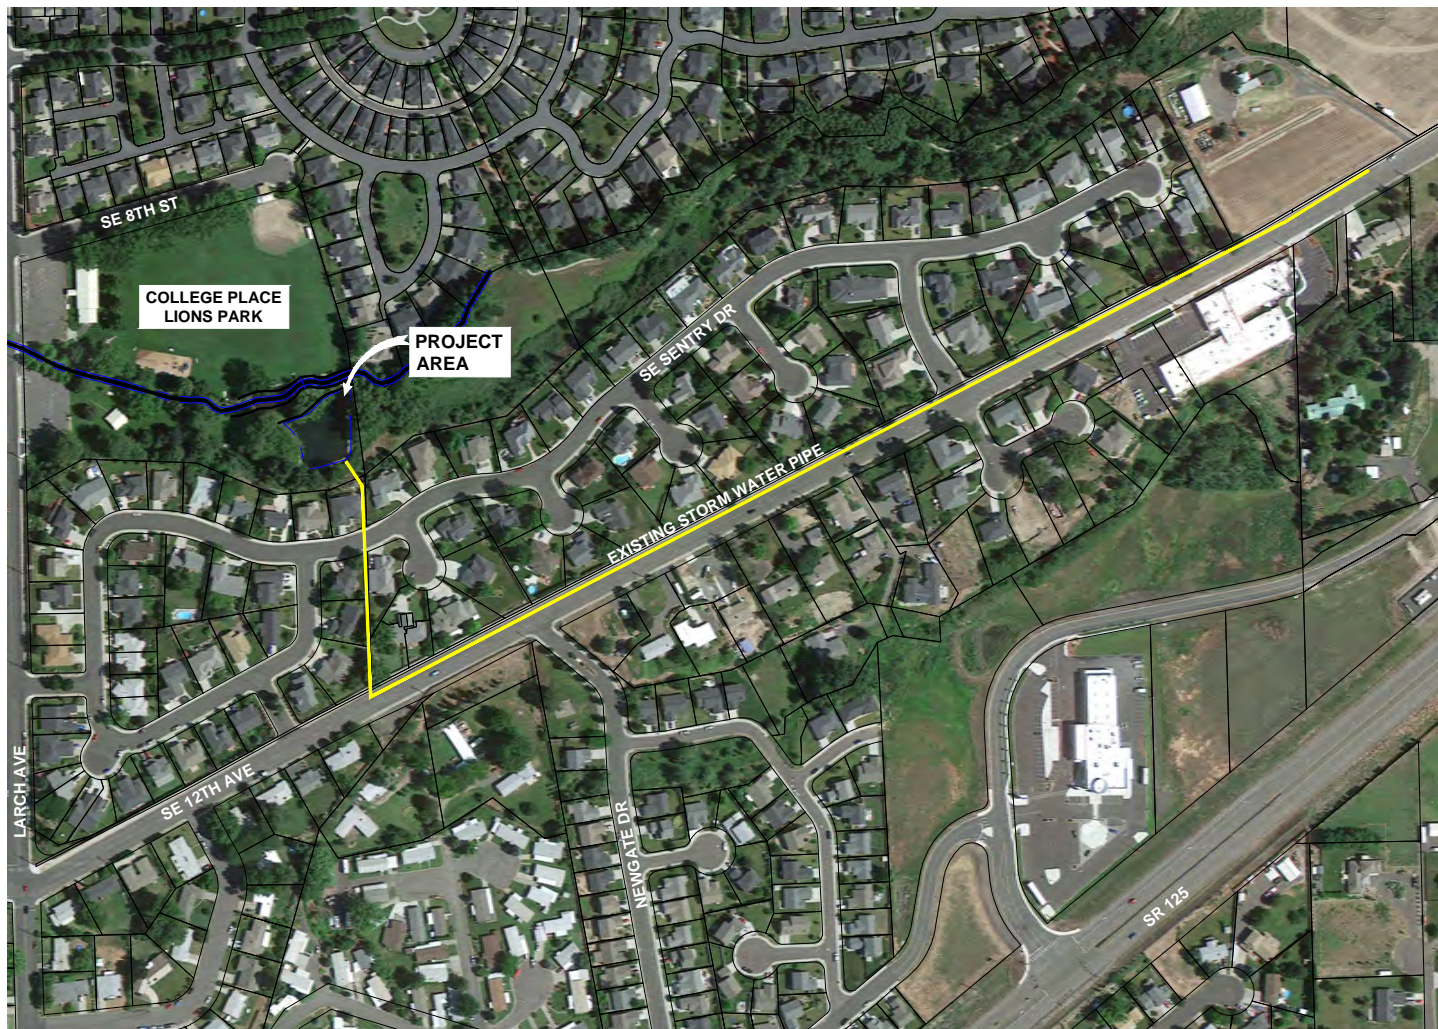
**FIGURE
1**

**CITY OF COLLEGE PLACE
LIONS PARK
VICINITY MAP**

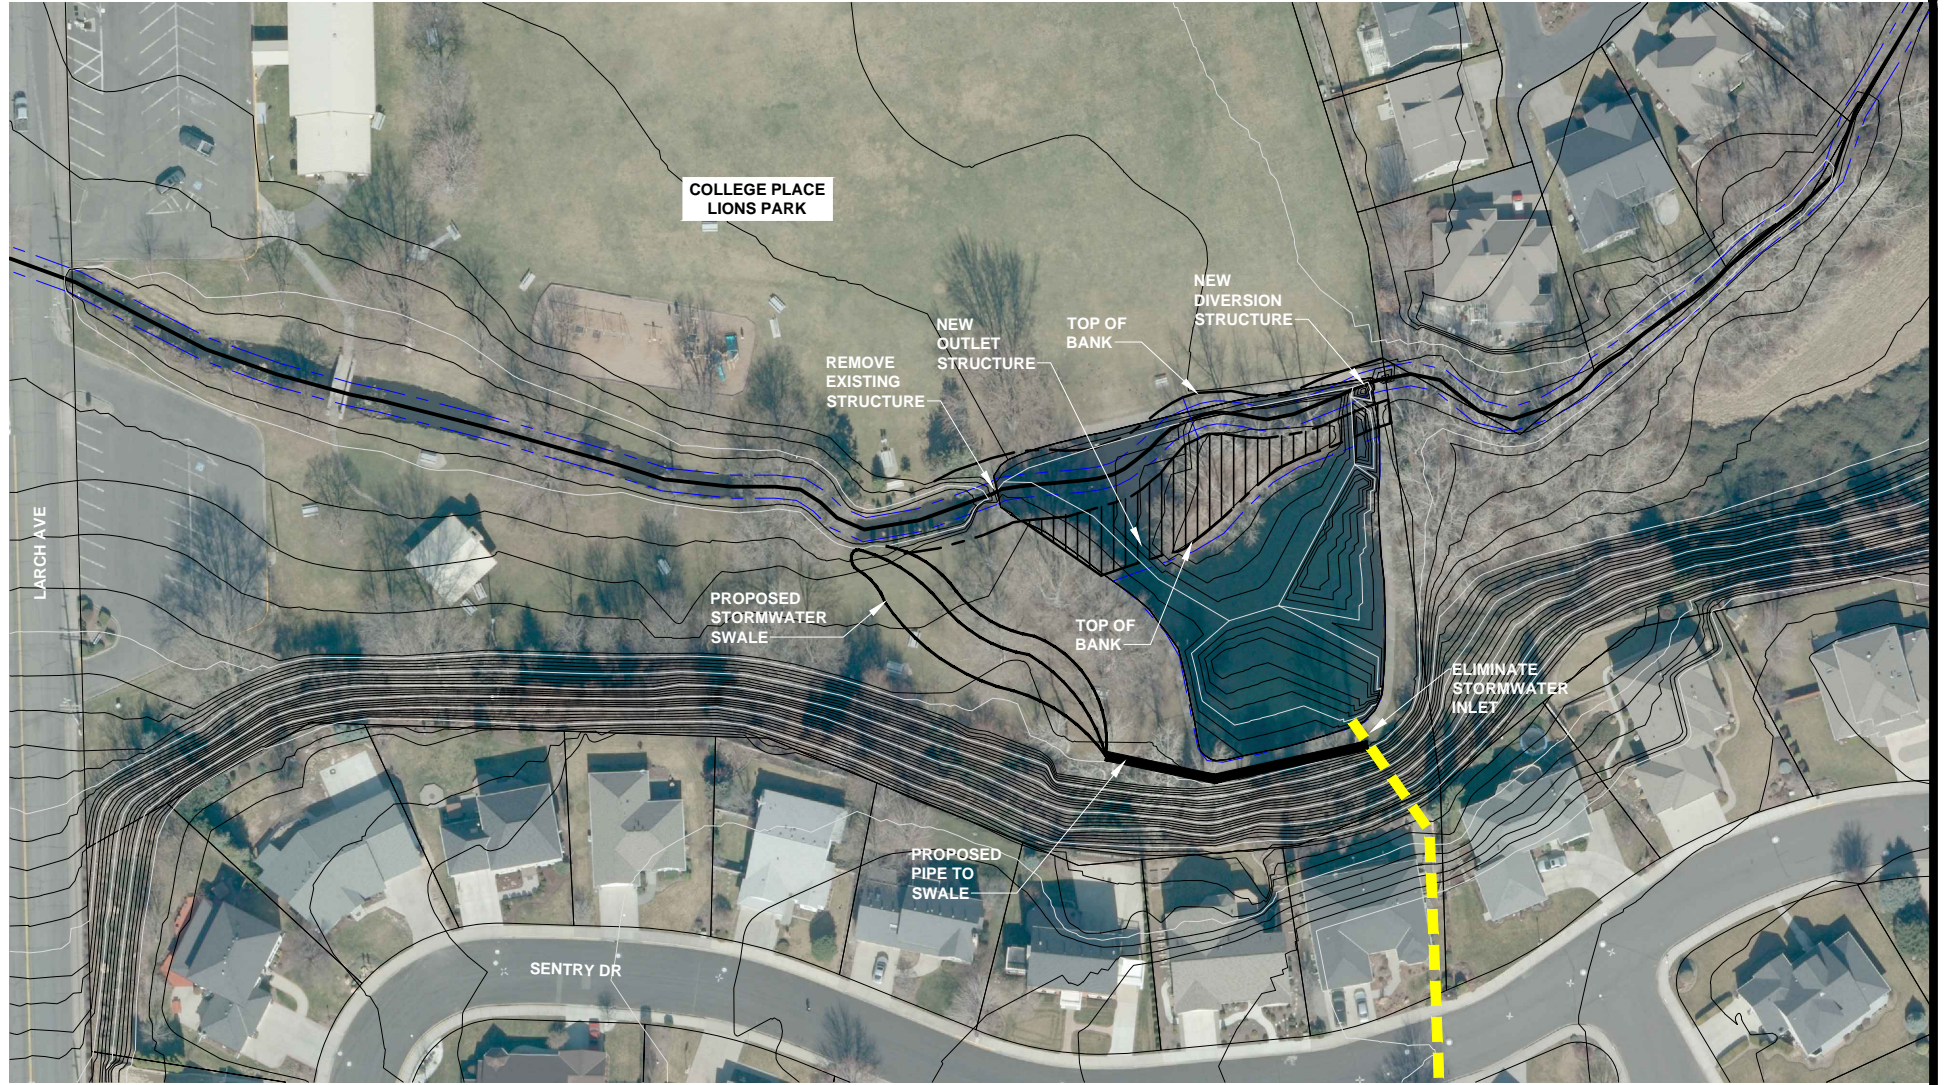
FIGURE
 2

CITY OF COLLEGE PLACE
 LIONS PARK
 FISHING POND IMPROVEMENTS
 SITE PLAN
