MILL CREEK - SPOKANE TO PARK

PROJECT # 19-1614

BASIS OF DESIGN REPORT

Waterfall Engineering

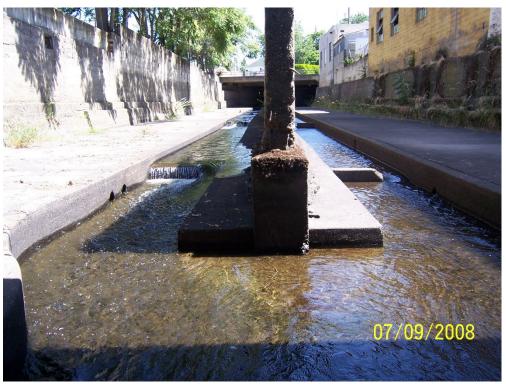
Photo 1 – Downstream end of project showing center wall and concrete footings just upstream of Spokane Street.

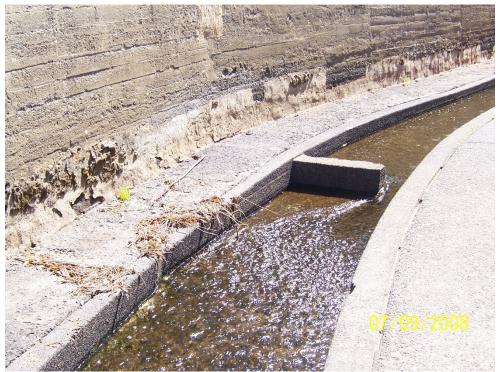
Photo 3 – View upstream in Reach Type 7 with flat overbank showing 4.5-foot-wide trench and 3.5-foot-long baffle.

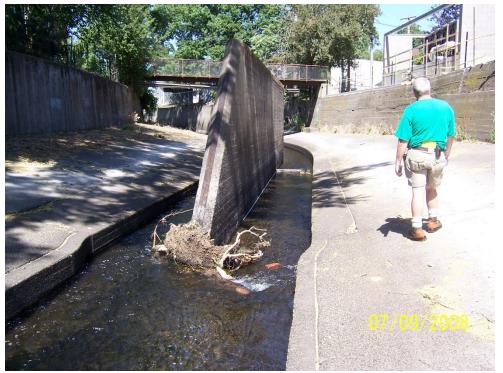
Photo 5 – View downstream of Reach Type 7 with sloping overbanks showing upstream end of wall and debris line. The foot bridge in the background is Marcus Street.

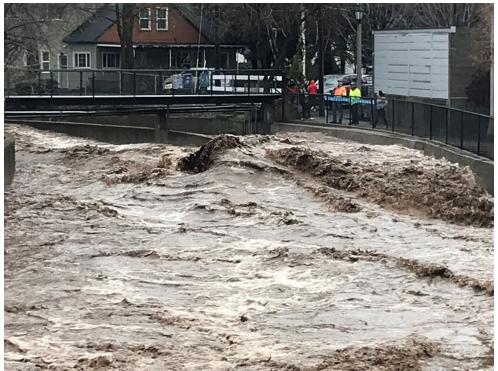
Photo 6 – 3500 cfs View of center wall with Marcus Street Footbridge in background.

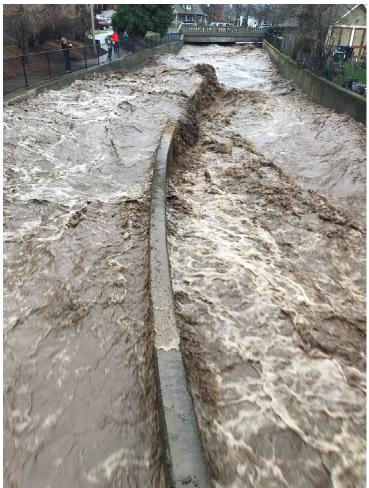
Photo 7 – 3500 cfs flow view upstream towards Park Street.

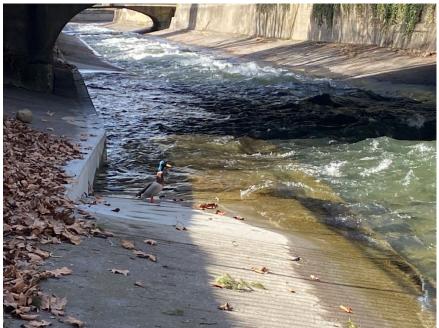
Photo 9 – View downstream of the Merriam Bridge. Unlike the typical Reach Type 3 Channel the left overbank (truck path) is submerged and carries a lot of water which reduces the effectiveness of the boundary layer. On average the velocities in the roughness panel are 0.5 fps higher than sections with no overflow.

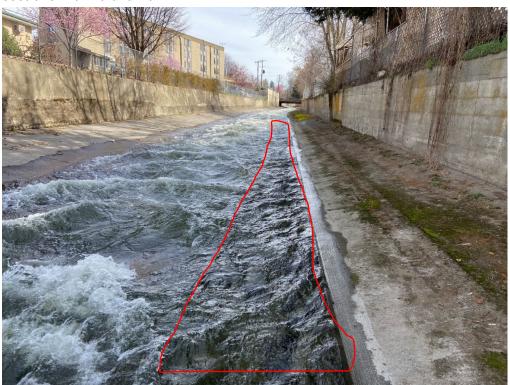
Photo 10 – View upstream showing roughness panel boundary layer. The velocity varies +- 0.3 fps parallel to the flow due to the standing waves which form every 15 to 20 feet from the baffles across the channel.

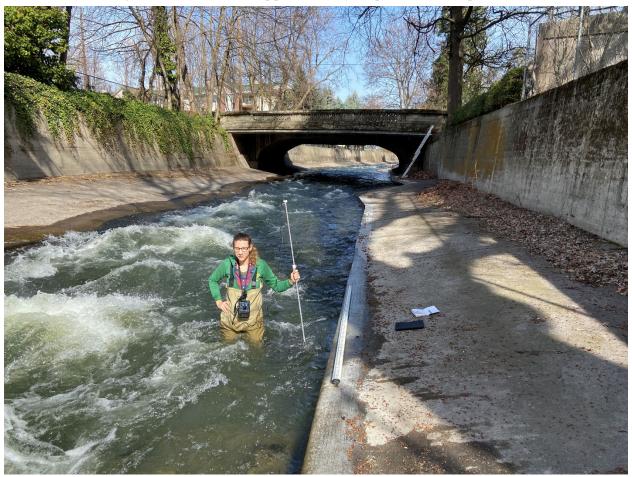
Photo 11 –Resting Pool 5 just downstream of Merriam Street. Velocities on the left side of the photo are 6 to 8 fps, but only 1 to 2 fps in the pool.
